# Rehabilitating Peripheral Health Units to Save Lives

## WASH/IPC UPGRADES

## Rehabilitation

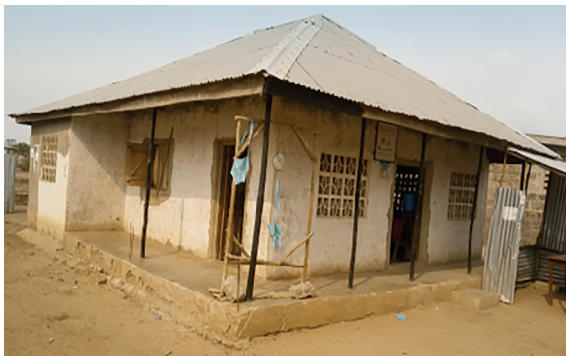
*Benguima Grassfield Maternal and Child Health Post before renovation.*

PHU building upgrades and repairs included ceilings, roofs (new corrugated iron sheeting), walls, floors, painting, handicap accessibility, stencils to indicate the type of room in the facility, improvements to windows and doors for security, and provision of medical equipment and non-clinical furniture.

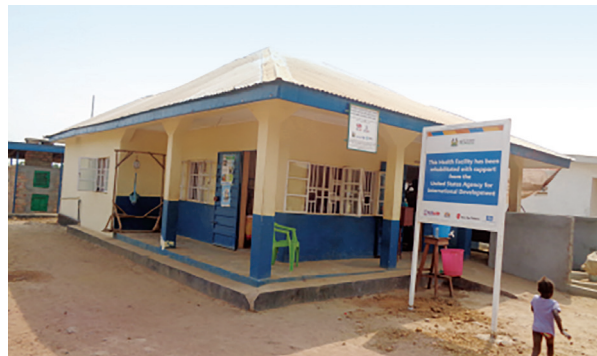
*Benguima Grassfield Maternal and Child Health Post after renovation.*

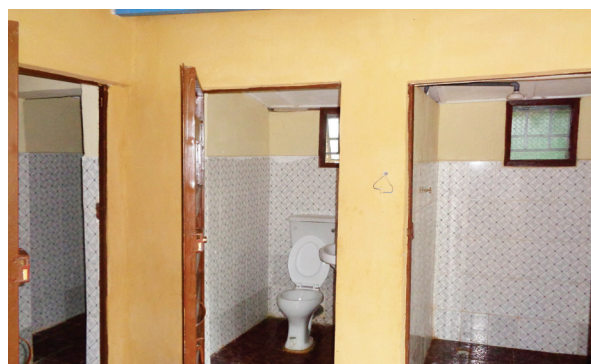
*Sussex Maternal and Child Health Post shower and flush toilet.*

The project repaired or installed toilets with dedicated septic systems and supported improved waste management systems, with focus on the addition of IPC pits (placenta, sharps, and ash pits) and repairing or building functional incinerators. At some posts, showers and flush toilets were rehabilitated in delivery rooms and soak-away pits attached to drainage channels.

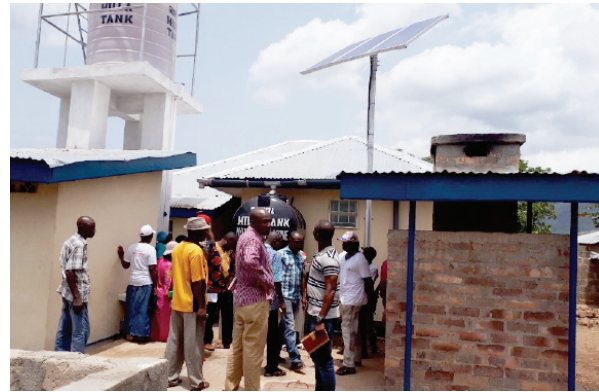
*Solar light and water tower with tank at Benguima Grassfield Maternal and Child Health Post.*

Borehole projects at any given site consisted of the following stages: 1) geophysical survey(s); 2) drilling and water-quality testing; 3) securing the borehole; 4) installing the water tower and tank; 5) installing piping to the PHU; and 6) installing solar-powered submersible and hand pumps.

The project's solar technical specifications for PHUs were developed in cooperation with and approved by the MOHS. 108 of the 110 PHUs received eight LED bulbs producing a minimum of 500 lumens each, with two waterproof fixtures for installation outside the entry/exit doors. Because of past problems with solar panels mounted on PHU roofs, the panels were mounted outside the PHUs on 12 ft. poles with supporting frames and protected with anti-theft screws. The systems provide a minimum of 10 hours of continuous nightly operation and can recharge a hand-held lantern (or head lamp), as well as mobile phones.

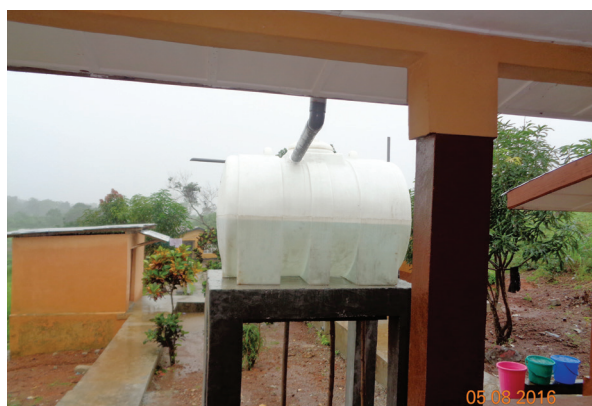
*Rain-water catchment system at Tokeh Maternal and Child Health Post.*

Tokeh Maternal and Child Health Post, located within Western Area Rural District and supported by Save the Children, was one of the PHUs that received a borehole. Because boreholes should only be drilled when the water table is low, several sites, including Tokeh, had to wait. As an interim solution, the project installed a rain-water harvesting system that captures rain through the PHU's gutters and channels it to a 2,500 liter storage tank. The tank is connected to the maternity ward bathroom, piping clean water to the sink, toilet, and shower for more sanitary births.
